# marantz

model number 18	bulletin number 69-01/18-1	date
for serial numbers	to	
subject REPLACEMENT OF DIODES IN 12 VOLT SUPPLY

model number 18	bulletin number 69-2/18-2	date
for serial numbers	to	
subject REPLACEMENT OF REFERENCE DIODES IN POWER AMPLIFIER.

model number 18	bulletin number 69-3/18-3	date
for serial numbers	to	
subject MODIFICATION OF STEREO PHOTOSWITCH

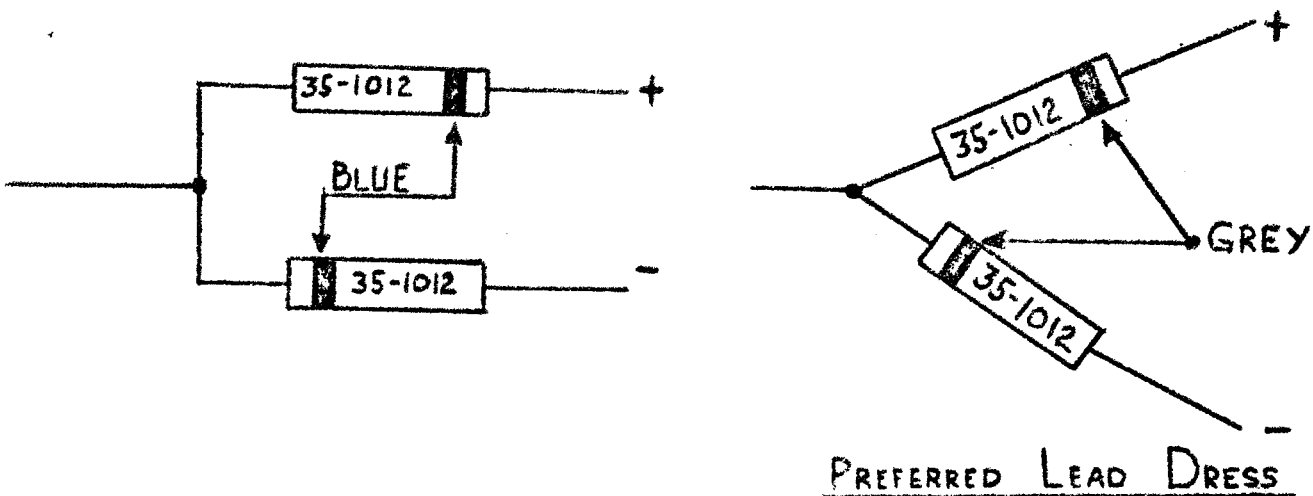
For improved reliability and performance the two Zener Diodes (CR-10 & CR-11) are being replaced by a new type. These diodes are located behind the power transformer on the top main chassis. They provide regulation for the FM sections, scope display and tone amplifier. Their failure will result in a loss of FM operation, scope display or if the fault is in the plus side of the 12V supply (CR-10) it will cause a loss of output on both channels.

The older type, to be replaced, is identified by a blue band. Its leads will be dressed at right angles. the NEW TYPE is identified by a GREY band. This is illustrated below with a drawing showing the old and the preferred new installation.

The part number for the diodes remains the same: 35-1012

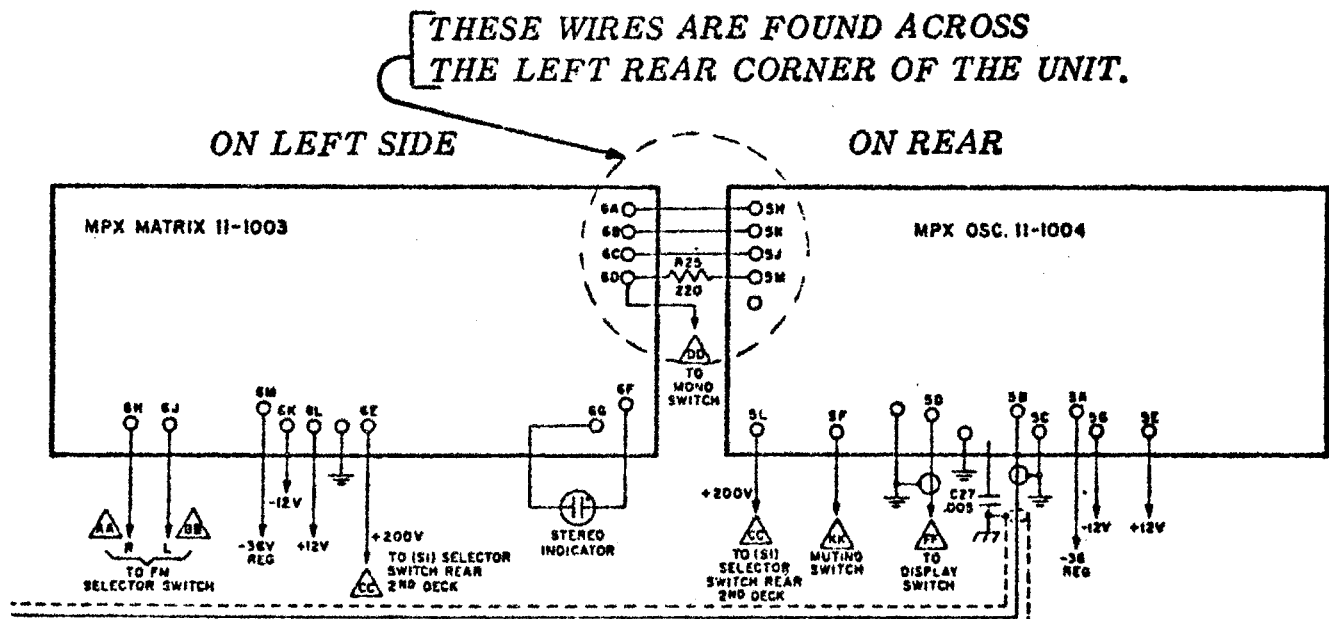
**FIGURE I:**  
MR9-054d

The following circuit modification is designed to correct the intermittent stereo operation in the FM mode which results from improper operation of the STEREO PHOTOSWITCH, LDR602.

1. REMOVE the three wires between the terminals of the MPX MATRIX board and the MPX OSCILLATOR board (See FIG.1). Also remove one side of resistor R-25.
2. REMOVE the two screws which secure the MPX Matrix board to the main chassis. Carefully pull the board away to expose the foil side.
3. INSTALL two insulated wire JUMPERS across both sides of the STEREO PHOTOSWITCH, LDR602 as shown in FIG.2. This effectively bypasses its operation.
4. REPLACE the matrix board on the chassis and re-solder the wires and resistor removed in step one above.

NOTE: IF THE PREVIOUS WIRES WERE SOLID, REPLACE THEM WITH STRANDED WIRE FOR GREATER FLEXIBILITY.

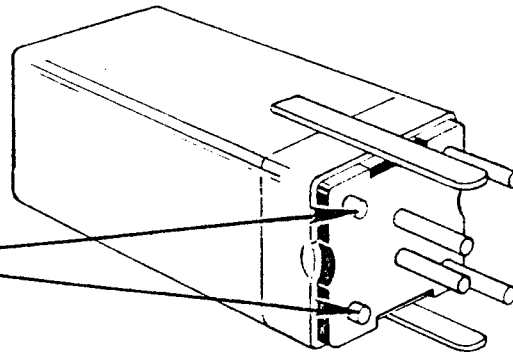
Replacement  
LIGHT CELL ASSEMBLY, LDR501  
P/N 331-1005-000

The original LIGHT CELL ASSEMBLY, Ref. Desig. LDR501, Part Number 11-1010 is no longer available and has been replaced by Part Number 331-1005-000.

Cut (2) Leads
