TECHNICAL BULLETIN

YAMAHA ELECTRONICS CORP., USA

Number: **235H**

MODELS AFFECTED: **RX-V1**

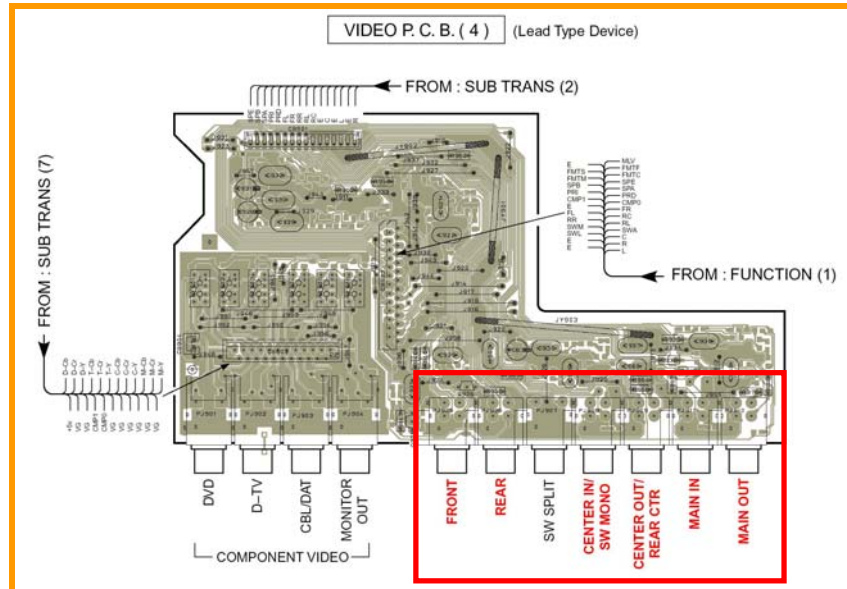
SYMPTOM: Intermittent weak output or distortion from one or more speaker channels. Inserting and removing an RCA plug into the Pre Out or Main In jack for the suspected channel may temporarily restore normal output.

CAUSE: Poor electrical connection at the internal switch contact inside the Pre Out and/or Main In jacks.

SOLUTION: Replace the Video (4) PCB or ALL of the jacks listed in the table below, even if only one jack is defective. (PJ907 for the subwoofer does not apply.)
