Title: **RMX 2450 AC Wire Routing**
 Bulletin #: RMX0004 Issue Date: November 3, 2000
 Models Affected: RMX 2450 Bulletin Revision: A
 Production Range: 01/2000–10/2000 (serial # 0100xxxxx–1000xxxxx)

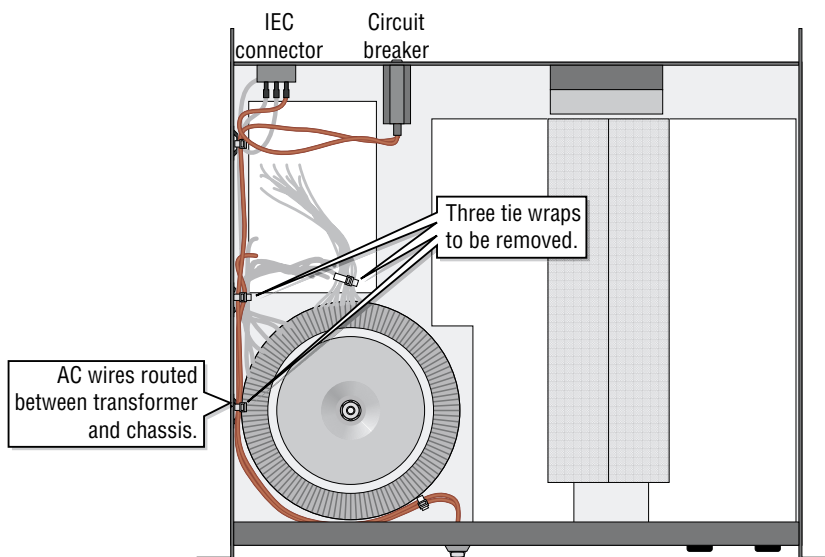
In the RMX 2450, the wiring to the AC switch is routed at the factory along the side of the chassis and secured with tie wraps to small loops (called bridge lances) in the chassis. One bridge lance lies right next to the toroidal power transformer with only a few millimeters to spare. In shipping or handling the amplifier, the potential exists for the transformer to shift and/or the chassis to flex, causing the transformer to pinch or abrade the wires against the bridge lance, and possibly cause it to cut through the insulation on the wire. This could short-circuit the AC current to the chassis, a very dangerous situation.

Figure 1. The amplifier before modification.

1. Disconnect the amplifier from AC and wait a couple minutes for internal voltages to bleed down. Remove the top cover.
2. Cut and remove the three tie wraps shown in Figure 1. Be careful not to cut into the wires or their insulation.
3. Disconnect the brown AC wires from the power switch. Lift the wires out from between the transformer and the chassis.

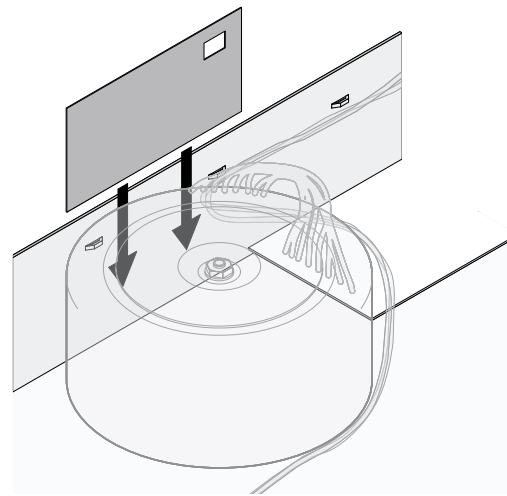
Figure 2. Inserting the insulator board between the chassis and the transformer.

6. Reroute the wires around the transformer as shown in Figure 3.
7. Slide the large sleeving over the two wires and reattach the quick-connect terminals to the switch terminals.
8. Orient the insulator board with its hole up and to the rear. Slide it into the space between the transformer and the bridge lance on the side of the chassis, and between the wires and the chassis (Figure 2). Place the hole in the insulator board over the middle bridge lance.
9. Slip a tie wrap through the bridge lance; it will hold the insulator board in place. Bundle the wires with the tie wrap so they are supported, but do not tighten the tie wrap so much that it strains them.
10. Bundle the two brown wires with the secondary wires and bind them all with a tie wrap.

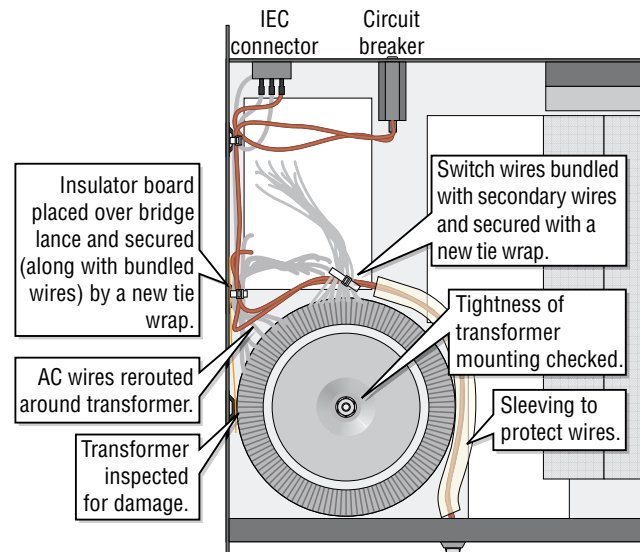
Figure 3. The amplifier after modification.
