tech bulletin

No: E2039tb

SUBJECT: MR100 FIELD PROBLEMS

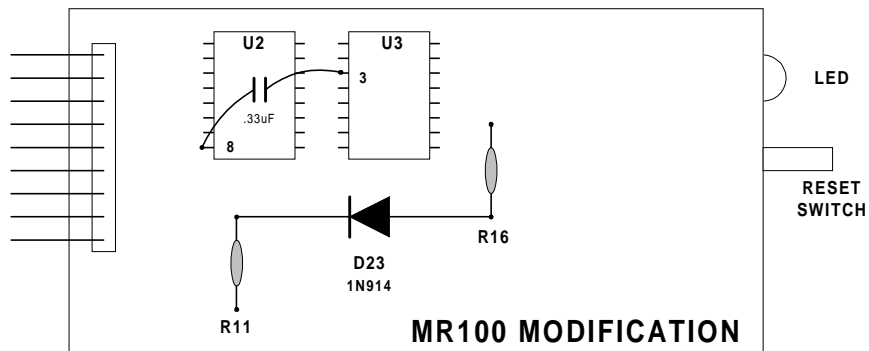
Item #1 - The MR100 produces a feedback tone signal to the user indicating that a connection has been made to the MR100. In some cases, this signal may be misinterpreted by the MR100 as a valid DTMF tone. When this occurs, an unintended command can be initiated (e.g. a VCR or Laser Disk Player may spontaneously stop or go into fast reverse). This problem has been resolved in units shipped from Rauland since 7/1/95. If your system is displaying similar symptoms a modification can be made to the MR100 to correct it.

The change involves the following:

1. Add a 0.33 uF capacitor (C16) directly across the DTMF receiver (U2) from ground (pin 8) to +5V (U3 pin 3)
1. Add a 1N914 diode (D23 from the bottom leg of R16 (anode) to the top of R11 (cathode)).
