# Diffusing current trouble

Variable frequency drives can cause voltage buildup on motor shafts. Several methods — one fairly new — can channel it away.

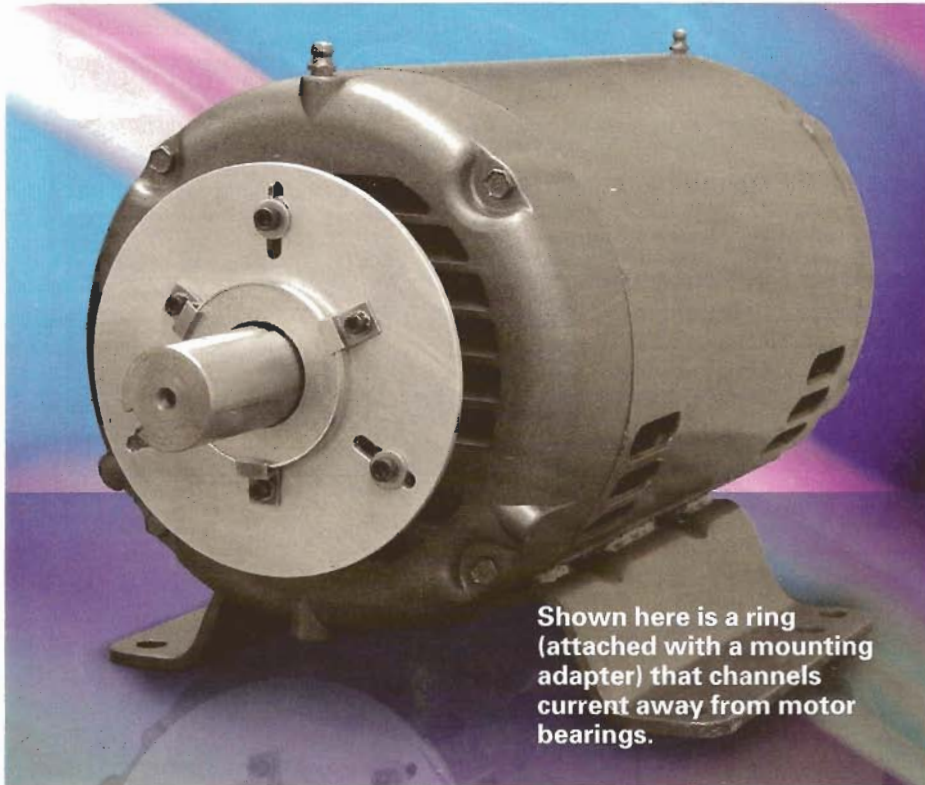
Shown here is a ring (attached with a mounting adapter) that channels current away from motor bearings.

⑥ **Shaft grounding rings** consist of a ring of engineered conductive microfibers that redirect shaft current through a low-impedance path from shaft to frame. The synthetic, nonmetallic rings don't rely on friction for connection; instead, they're fit over either end of the motor shaft and lock in place with simple screw-on mounting brackets. (A split-ring design allows installation around the shaft without disassembling attached equipment.) Then ionization boosts the electron-transfer rate to promote discharge of high-frequency currents. The microfiber design makes for hundreds of thousands of discharge points, so the ring channels shaft currents around motor bearings to protect them from electrical damage.

Conductive microfiber shaft grounding rings are scalable to NEMA-frame and larger motors, and designed for motors with shafts from about 0.3 to 6.0 in., including IEC frames and high-horsepower ac and dc motors. No machining is required, and the rings can be installed in minutes — even in the field. Once installed, the rings require no main-

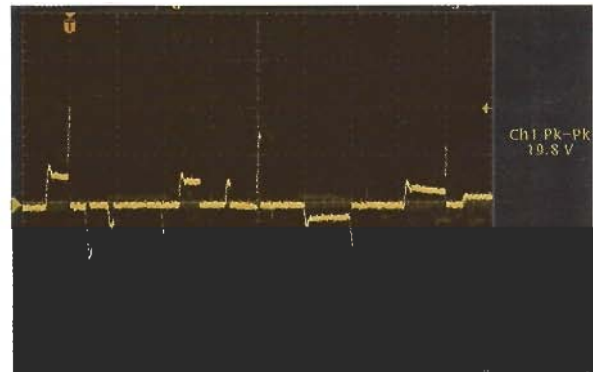
### In circulation

The high switching speeds and parasitic capacitive coupling between stator and rotor induce currents on the motor shaft (inset) and magnetic flux imbalances cause circulating currents.
