Hi-Fi Products  
Service Bulletin

**Model:** STR-VX550

**No. 3**

**Subject:** Missing 1S1555 Diode

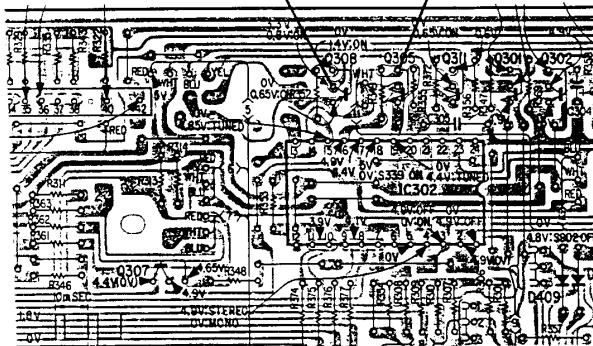
DISPLAY BOARD

Early production of STR-VX550 diode 1S1555 was omitted from the display board.

Add Diode 1S1555  
Part No. 8-719-815-55

When servicing STR-VX550, check if this diode is installed. If the diode is missing, solder a 1S1555 between collector of Q308 and base of Q305. The cathode should be connected to the collector of Q308.
