# TV Service—and the Ladies

By  
HAL ROSEN

# UNUSUAL OCCURRENCES

# Art's TV Shop

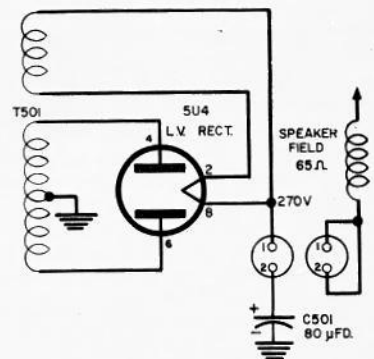
Fig. 1. Cause of this 5U4's demise was easier to understand than the set owner.

A 17-inch *Admiral* table model stood quietly in one corner, with a basin placed under it to catch the stuff that had dripped from the cabinet. Les removed the back and turned the set on. The low-voltage rectifier (Fig. 1) didn't light, so he tried a new 5U4 and turned the set on again. Its plates began to glow cherry red quickly, so he turned the set off right away.

Measuring from pin No. 8, the cathode, to ground with his ohmmeter, he read zero ohms. With the meter still connected, he pulled out the plug from the speaker field coil. The pointer swung up to an infinite reading. This might have suggested a short somewhere in the set beyond the first filter capacitor. In that case, however, he would certainly have read the resistance of the field coil, instead of zero, when the speaker plug was in. The likeliest culprit, then, was  $C_{501}$ , the 80- $\mu$ fd. filter capacitor—and he was right on the nose this time.

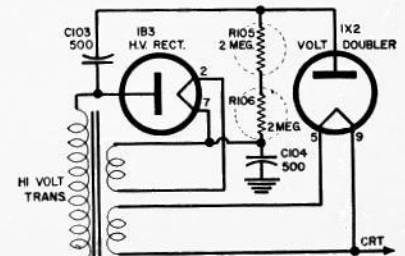
Fig. 2. Arcing, not an electron leech, "sucked power" from this h.v. circuit.

replaced the 1B3 rectifier (Fig. 2). In a few moments the picture bloomed again. Eddie re-inserted the old rectifier and darkened the room to check for possible arcing. He discovered a slight, bluish light in the center of the 2-meg-ohm resistor,  $R_{105}$ , and knew he'd found the trouble. Eddie explained what had happened as clearly as he could and recommended that  $R_{100}$  be changed as well. The lady agreed and he replaced both resistors.

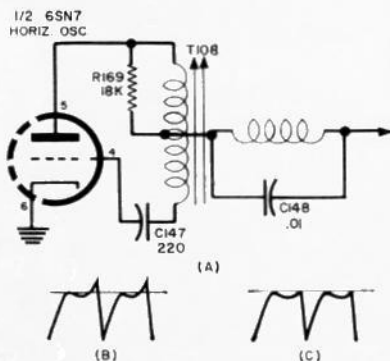
**Fig. 3. The female owner knew all about this horizontal oscillator.**

until the two peaks of the waveform were "in line" (Fig. 3C). Then he removed the scope connection and checked the horizontal-hold control. He noted that the picture would lose horizontal sync only at the extreme ends of the control's range. Satisfied, he installed the chassis, made a few vertical adjustments, and wrote up his bill. The lady paid him and thanked him for the prompt service.

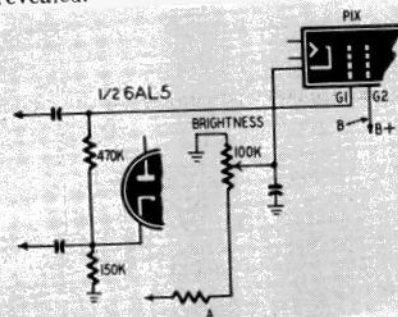
Fig. 2—This works despite a high-resistance short between G1 and G2.

One of the sets had a high-resistance short between grids 1 and 2 of the picture tube. Result—picture much too bright. The set is a Crosley 9-419M. Fig. 2 shows the changes made. The resistor at A was 220,000 ohms. I reduced it to 100,000 to raise the cathode potential. Reduced the B-voltage to grid 2 (point B) to bring brightness down further. Result—good contrast!

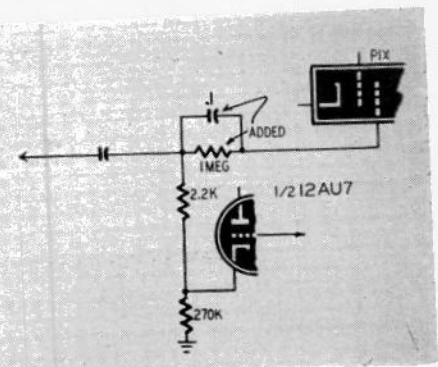
Fig. 3—A temporary remedy for heater-cathode leakage in a TV picture tube.

The other two sets were both high-resistance grid-cathode shorts in Meck MM614C's. The shorts spoiled sync take-off by cutting out the d.c. restorer tube. The solution in Fig. 3 leaves some effect of d.c. restoration. That in Fig. 4 eliminates d.c. restorer action, but customer is satisfied.

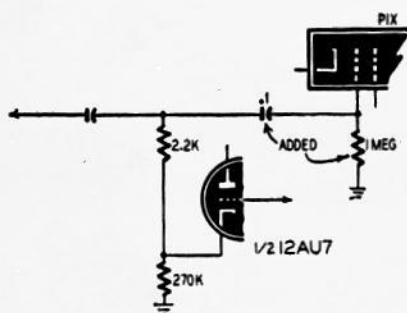
Fig. 4—Another method of overcoming the effects of a high-resistance short between heater and cathode in the picture tube by eliminating d.c. restoration.

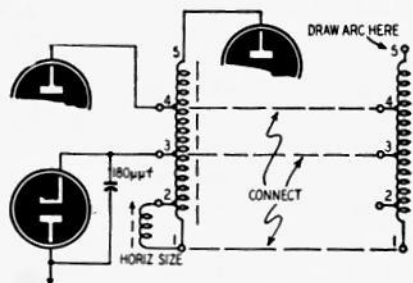
Fig. 5—Flyback substitution test setup.

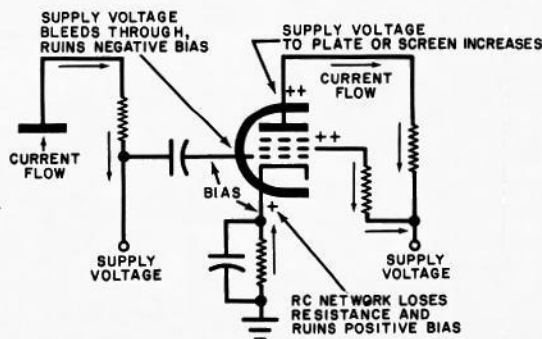
Fig. 1. Three possible reasons for excessive plate current are shown.

Now what could be causing this 6GH8 to be drawing too much current? There are three immediate possibilities (Fig. 1). One, B-plus could have bled through to a control grid from the preceding plate. When that happens, the valve action of the tube causes too much current to pass the control grid vicinity. Instead of a normal negative bias, the control grid is positive, exercising no control. The tube runs wide open.

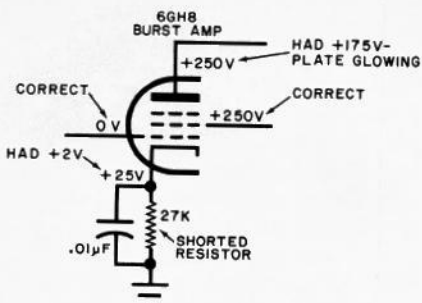
*Fig. 2. Voltage readings showed a shorted resistor.*

I plugged in the TV, grabbed the probe of my voltmeter and began reading voltages (Fig. 2).

Pin 3 the screen grid had plus 250 as prescribed. Pin 6 the plate was about 175 volts, somewhat low. Pin 2 the control grid had the zero voltage shown on the schematic. Pin 7 the cathode was wrong! It had plus 2 volts

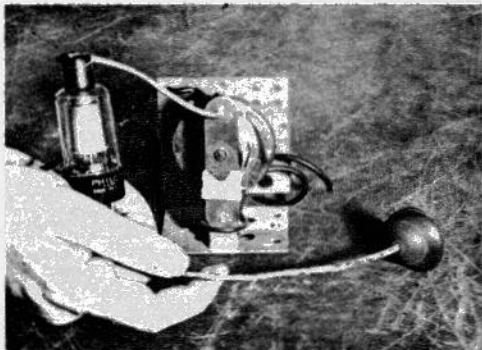
1B3 and 3A3 high-voltage tubes look exactly alike, often are mistaken for each other.

"Looks like you've been booby trapped," I said, breaking the news as tactfully as I could. "Your set takes a 3A3 high-voltage rectifier, not a 1B3. Even though the two tubes look exactly alike your 3-V heater

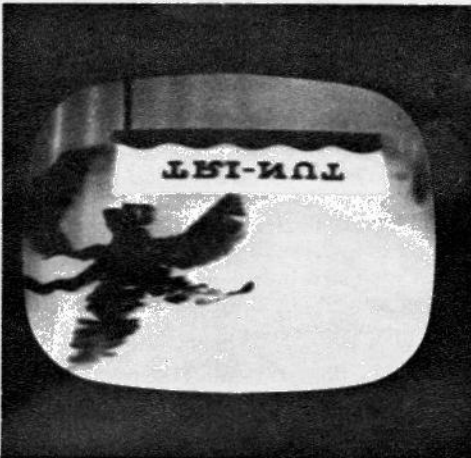
Reversing the leads of the deflection yoke results in reversed deflection of electron beam. Universal replacement yokes can't match color coding of all yokes they replace. You must peel off cover to match lead wires.

I explained that he probably had a bad deflection yoke. The yoke has four sections. The two vertical sections spread the picture out from top to bottom. The two horizontal sections spread the picture from side to side. Whenever one of the windings shorts, it's respective picture area shrinks. This causes the keystone-shaped picture. So I sold him a universal replacement yoke.

"Sorry about that, chief, but the colors don't match. A universal replacement is made for a hundred different TVs. You'll have to peel the cover off the old yoke, make a sketch of which wires are coming from which connections and match the new yoke to the old." He had been trying so hard to touch all bases in replacing the yoke that he had not stopped to consider what might go wrong.

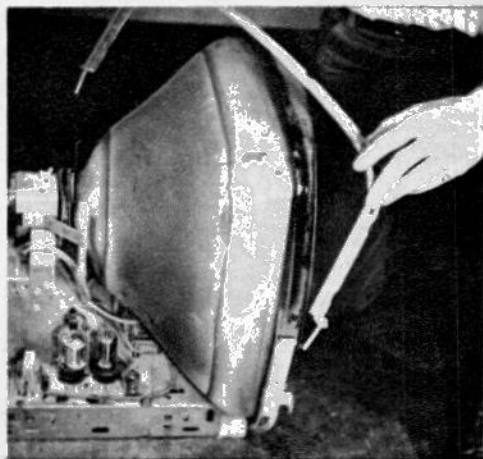
CRT circumference varies from tube to tube. Metal strap should be tightened only until it is snug around replacement, regardless of position on old tube. Tighten it too far and you will be in for some serious trouble.
