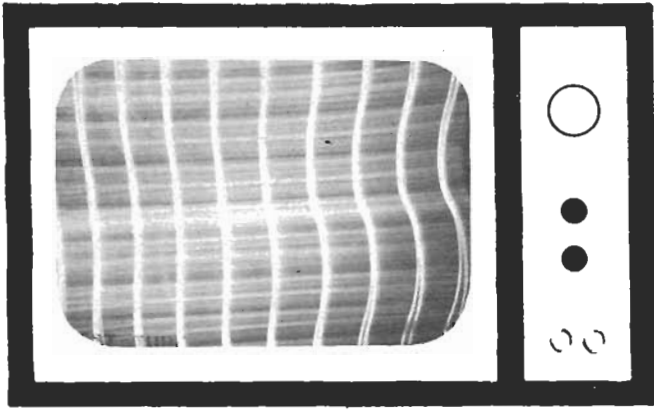
WHEN THE picture pulls and squirms as shown here, try adjusting the horizontal and vertical controls. If this does not help, try shunting the filter capacitors, one at a time, with a new capacitor with a rating of at least 100 μF and no less than the voltage at which the suspected capacitor is rated. (Do not forget the precaution noted earlier when doing this.) When the humbar condition disappears, you have located the faulty capacitor and can replace it with a new component. If the defective capacitor is in one can with other capacitor elements, replace the whole unit because the other elements are likely to become defective soon.

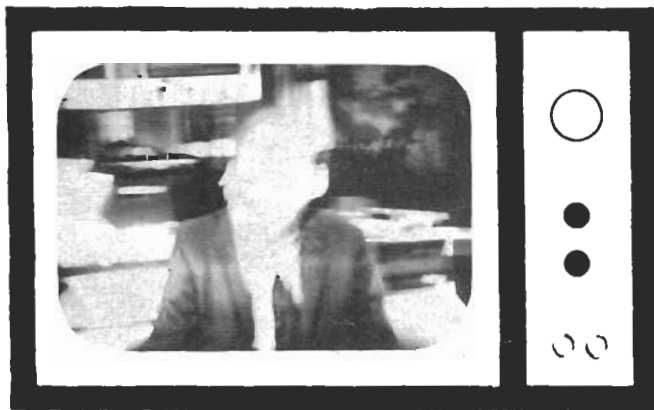
SOMETIMES when the brightness control is turned fully up, a picture may "bloom" or go out of focus. When the picture is out of focus all the time, no matter where the brightness control is set, suspect a defective picture tube, focus rectifier, or other component in the focus circuit. The first thing to do here is to locate the focus control on the rear apron and adjust for best focus. If that does not help, check for a defective component.

Look for a focus-rectifier tube near or on one side of the high-voltage cage. Typical tube numbers are 1V2 and 2AV2. If you cannot locate a rectifier tube, even after referring to the tube list on the side of the cabinet or high-voltage cage, the chassis uses a solid-state rectifier, which will be located inside or under the chassis. If you have access to a high-voltage probe, focus voltage should read 4.3 to 5.5 kV. A defective picture tube must be checked with a CRT tester.

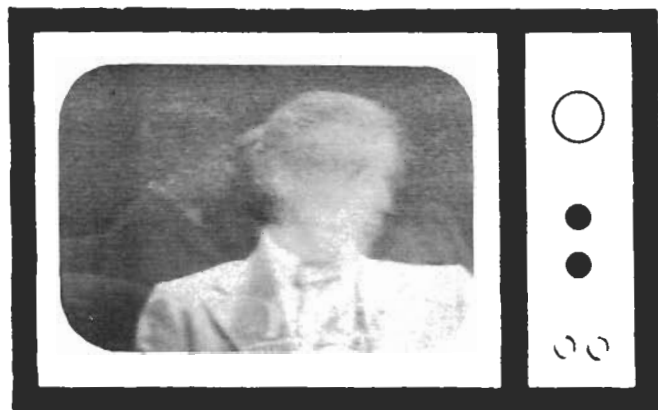
PERHAPS you have seen this picture problem before, with very thin lines running across the screen. Here we find a whole section of the picture masked by noise. This is not a receiver problem. It was the result of interference from a microwave oven, but could also have been caused by any other electrical appliance or even a fluorescent-lighting fixture. Sometimes an ungrounded furnace motor will produce such picture interference. By grounding the appliance or motor and plugging it into a noise-eliminator socket, you can do away with or drastically reduce the interference.
