Model: KP-53XBR45, KP-61XBR48

No. 388

Subject: Fuse resistor not listed

Date: January 20, 1999

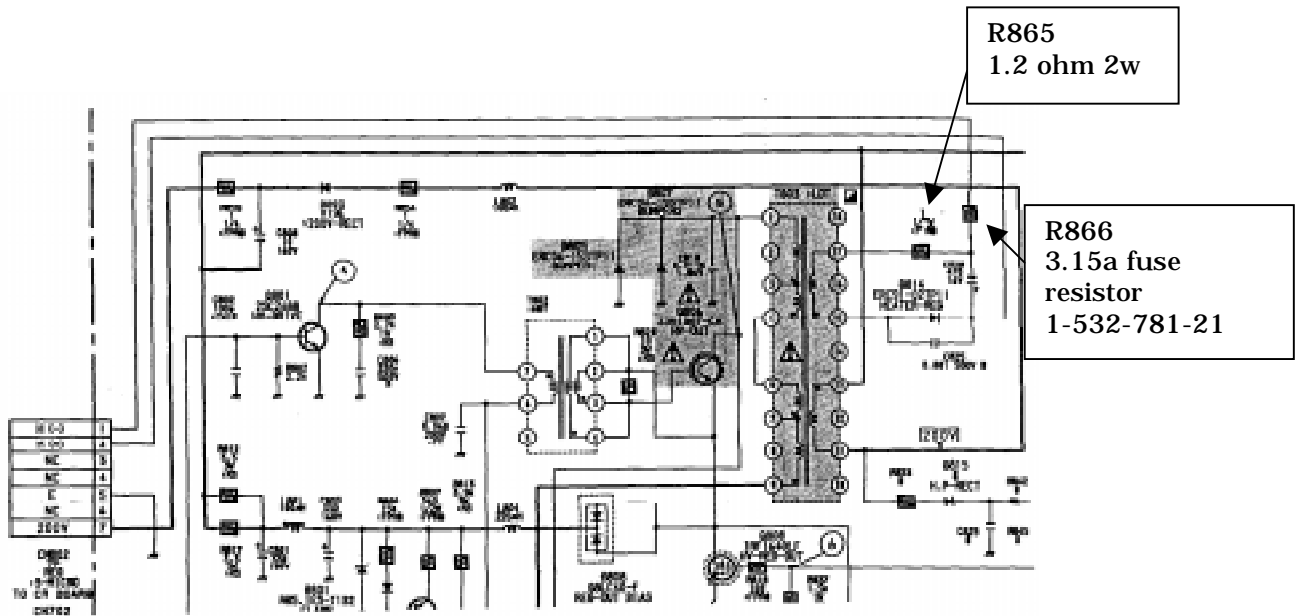
The E board was changed starting with Suffix -14. When fuse resistor R866 and R865 was added. Please see the schematic and Ref. chart below for the proper Part Number and schematic diagram.

This resistor is located between T-803/pin 17 and CN-802/pin 1. R-865 is in series with this fuse resistor.

Ref.	Description	Part Number
R865	1.2 ohm 2 watt resistor	1-216-370-11
R866	3.15a Micro Fuse resistor	1-532-781-11
