# marantz

model number 18	bulletin number 69-01/18-1	date
for serial numbers	to	
subject REPLACEMENT OF DIODES IN 12 VOLT SUPPLY

model number 18	bulletin number 69-2/18-2	date
for serial numbers	to	
subject REPLACEMENT OF REFERENCE DIODES IN POWER AMPLIFIER.

model number 18	bulletin number 69-3/18-3	date
for serial numbers	to	
subject MODIFICATION OF STEREO PHOTOSWITCH

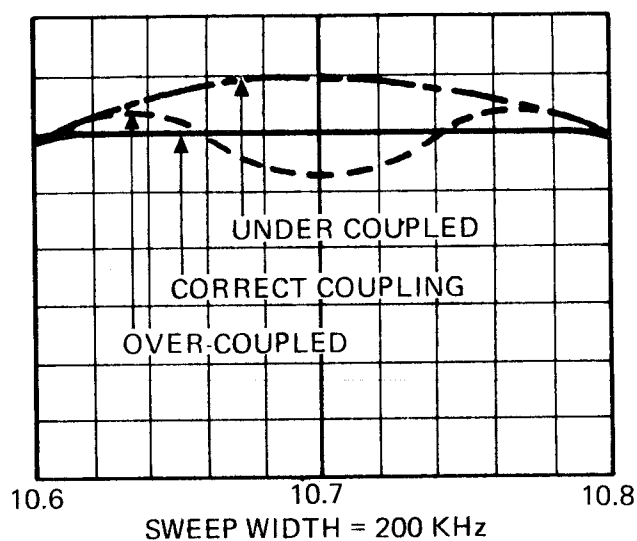
Figure 6. I.F. Bandpass Curve

Therefore, the response curve can not be any better than that of the first stage alone. Normally, the curve will degrade slightly (appearing more like the "under-coupled" curve) on the 200 KHz display as more stages come into play.
