Corrections & Updates

Transistor Curve Tracer

February 2009, p. 24-31, no. 080068-1

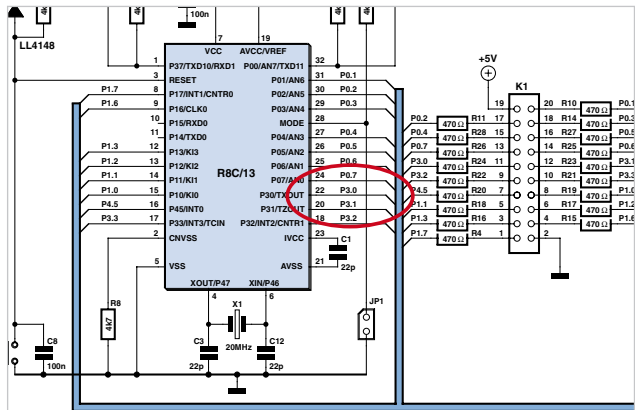
In the circuit diagram (Figure 2, section a), the bussed connection between pin 22 (P3.0) of the R8C/13 module and resistor R24 is missing. This connection is however present on the circuit board, for which no modification is required.

In the component list, transistor T2 should be a type BC557A, not BC547A. No modification is required to the PCB or the schematic.
